1.1 Project Background

The Buddy's International Hotel is under construction in the Providence area of East Bank Demerara. The 250 room hotel is being constructed on a plot of land approximately 3.2 *ha* in area situated at Tract 'BS' Block 2, Public Road, Plantation Providence to the north of the Guyana Cricket Stadium also under construction, Figure 1.1.

This Environmental Impact Assessment (EIA) was conducted by Caribbean Engineering and Management Consultants Inc (CEMCO Inc.) for the Buddy's International Hotel Project. The study was commissioned by Buddy's International Hotel Inc. 'The client' in order to fulfill the requirement for obtaining an environmental permit from the Environmental Protection Agency (EPA).

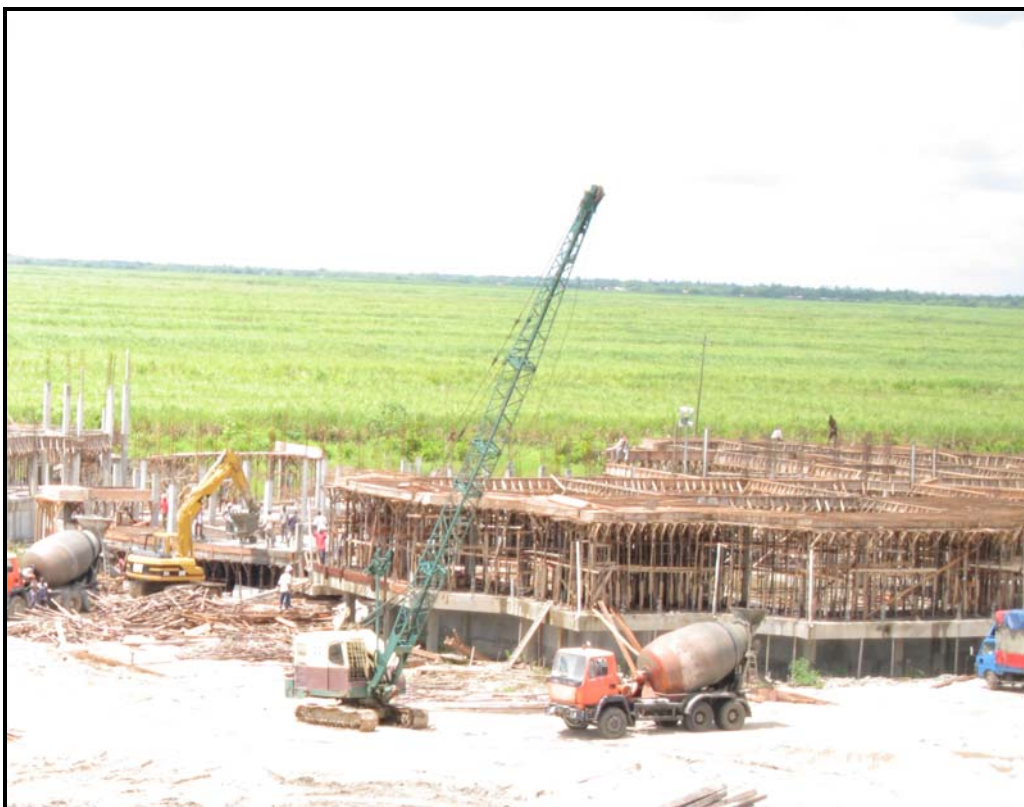
Plate 2.1.4: showing apartment building east of hotel under construction and sugar cane plantation.

The Buddy's International Hotel is being developed on lands originally used by GUYSUCO as a sugarcane plantation which was subsequently abandoned Plate 2.1.4. The lands have been acquired by the Guyanese Government and recently designated as a site for housing and other developments.

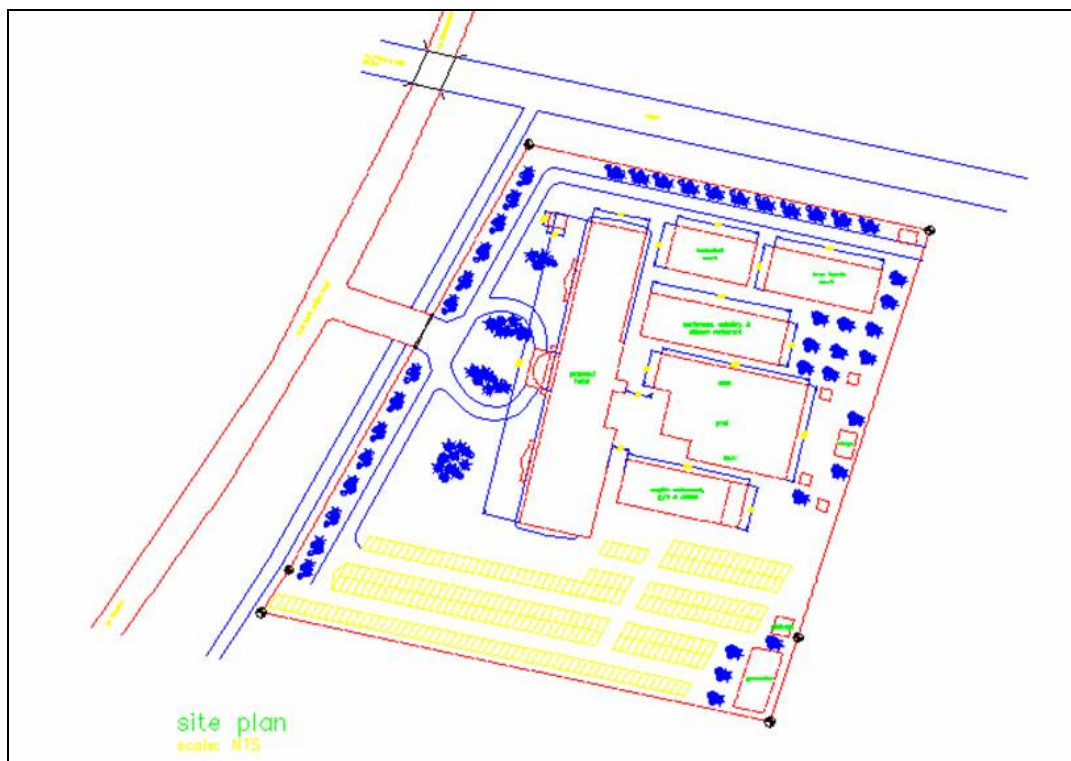
Fig 2.2: Layout Plan of Hotel

The hotel will include two hundred and thirty air conditioned rooms and twenty suites contained in a five storey building, See Appendix 6. (Conception ACAD drawing) The hotel will feature rooms with dimensions of 14 ft x 28 ft including internal fixtures and washing facilities. Figure 2.3 shows the layout of the main hotel components. The lobby area will house several small shops. A restaurant, conference room hair salon, gym, washing facilities and small shops are located to the rear of the hotel flanking a 60 ft x 100 ft. swimming pool. There will be two sets of fire escapes and an internal staircase as well as three elevators.

South of the main building is the parking lot which will provide parking for over three (300) vehicles. Basket ball and tennis courts are located in the north eastern corner of the property. A well and filter plant as well as the sewage treatment plant will be located along the northern boundary of the property.

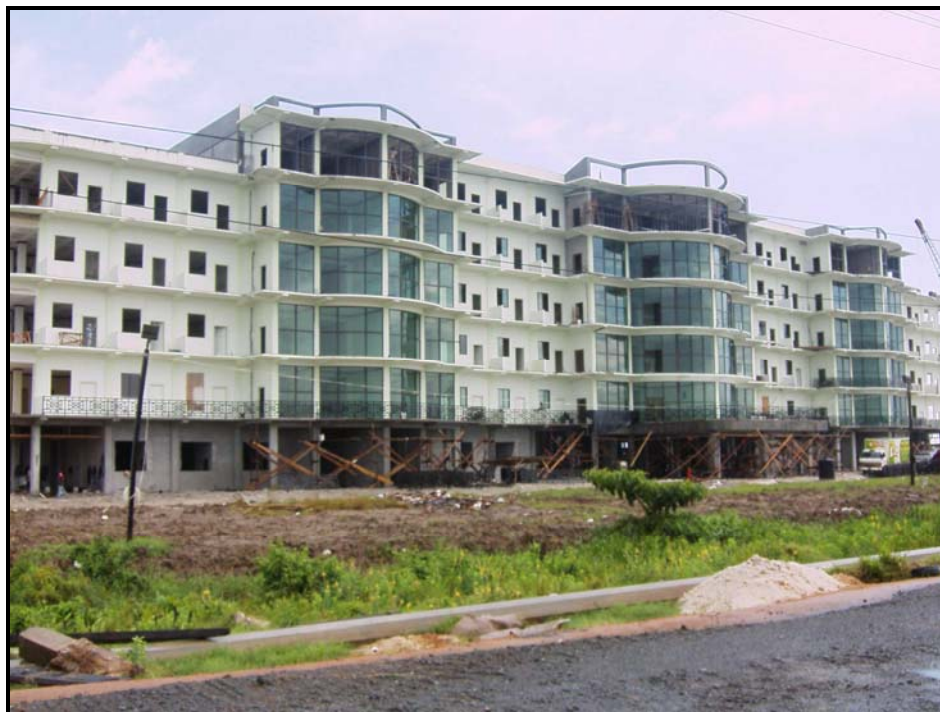
Plate 2.6.2.1: Front View of Hotel under construction

The hotel is 80% complete, Plate 2.6.2.1 and 2.x front and rear view of building with the site clearance, foundation and superstructure structural components complete. All internal and external concrete blockwork is complete. Glass cladding, internal and external finishes, electrical, plumbing, fencing, swimming pool, ancillary buildings and well for water supply and drains are ongoing.

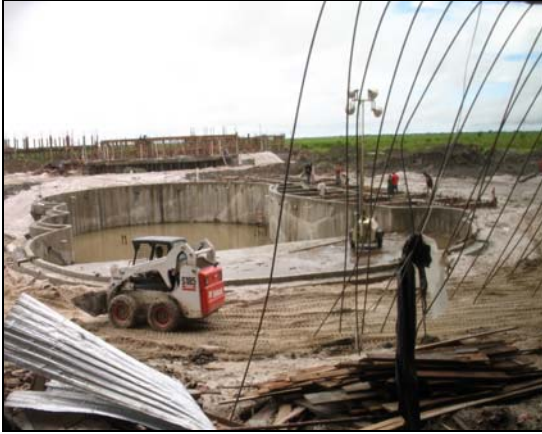
The swimming pool and the support service structures are partially complete, Plate 2.6.2.2 & Plate 2.6.2.3 (view of pool and buildings). The potable water producing well has been dug to a depth of 68 feet with final pump installation under way Plate 2.6.2.4.

Plate 2.6.2.2 : Showing swimming pool under construction

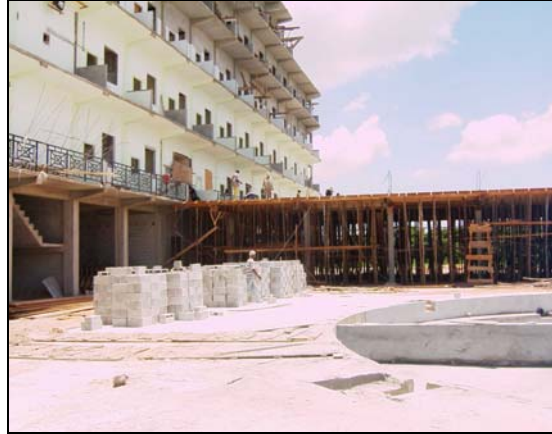
Plate 2.6.2.3: Showing adjoining restaurant building under construction.

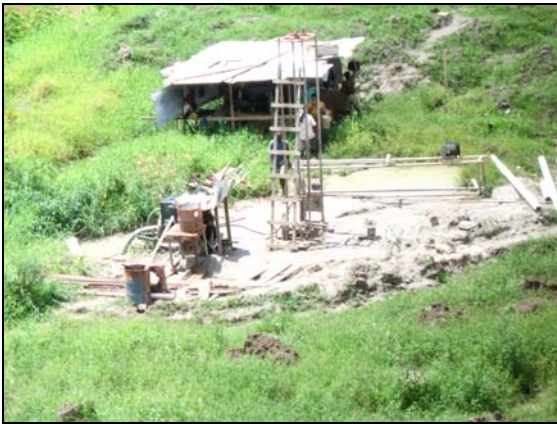
Plate 2.6.2.4: Well has been dug up to 68 feet

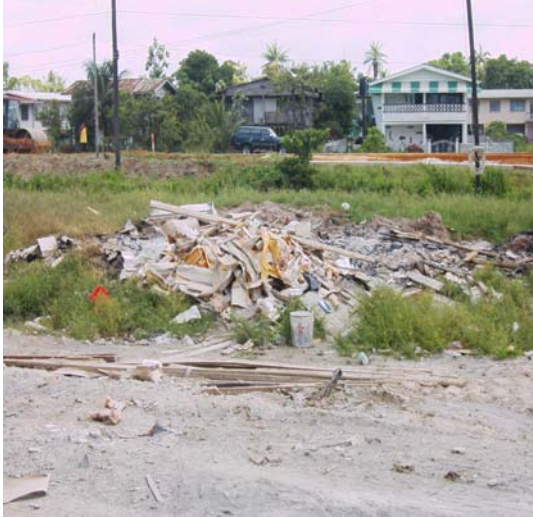
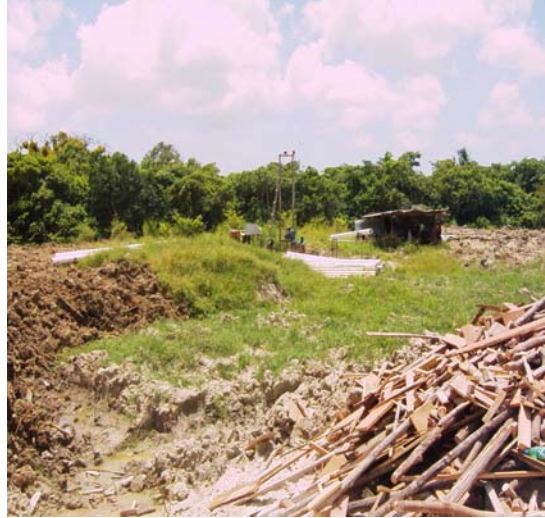
Checks on the hotel site during construction indicated that solid waste including rubble, lumber, paper and plastics were temporarily stored on the ground and subsequently disposed of off-site.

Plate 2.6.4.1: Construction waste

Plate 2.6.4.2: Construction waste material

This waste could negatively impact the site and surrounding environment if not properly managed and disposed of at an approved dumpsite. Solid waste, if allowed to accumulate in drainage ways, could cause localized flooding. Pooling of water, in turn, would create conditions conducive to the breeding of nuisance and health-threatening pests such as mosquitoes. Poor construction waste management constitutes a short-term, possibly long-term, negative impact.

- Unusable construction waste, such as damaged pipes, formwork and other construction material, must be disposed of at an approved dumpsite.
- Proper solid waste receptacles and storage containers should be provided in sufficient numbers, particularly for the disposal of lunch and drink boxes, so as to prevent littering of the site.

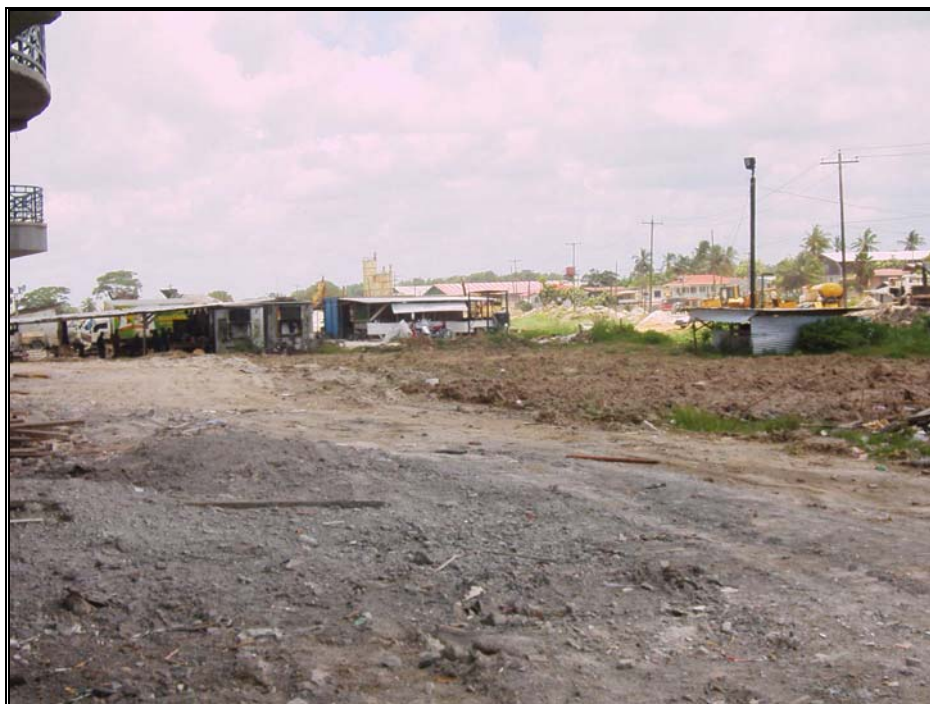
Materials such as coarse and fine aggregate are stockpiled. Lumber, steel, cement and other materials were stored in covered storage areas.

Plate 2.6.5.1: picture of storage building beside site office

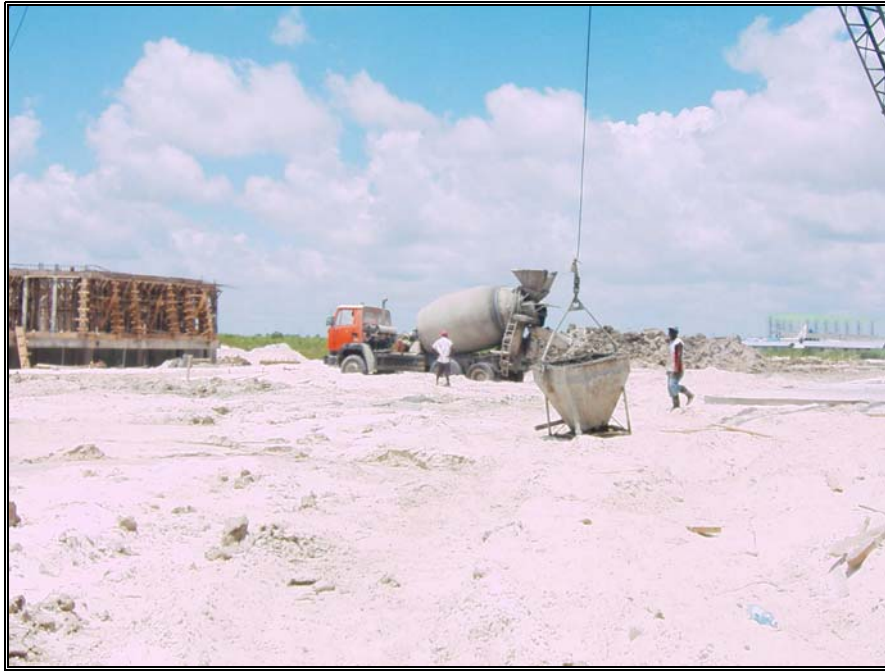
Dust as airborne particulates is generated by earth moving and other construction activities. Wind disperses the dust carrying it away from the source. The wind itself generates dust by carrying away fine particles from material stock piles and from dry ground surfaces.

Plate 2.6.8.1: Showing low level dust on internal site roadway

Earth moving activities during the hotel building construction and offloading of material has generated a certain amount of air borne particulate matter (dust). This situation was worst during the dry season. Given the location of the site of the site, air borne particulates should not pose a serious hazard to residents in the vicinity or downwind of the construction.

- Access roads and exposed ground should be regularly wetted in a manner that effectively keeps down the dust.
- Stockpiles of fine materials (e.g. Loam) should be wetted or covered with tarpaulin during windy conditions.
- Workers on the site should be issued with dust masks during dry and windy conditions.

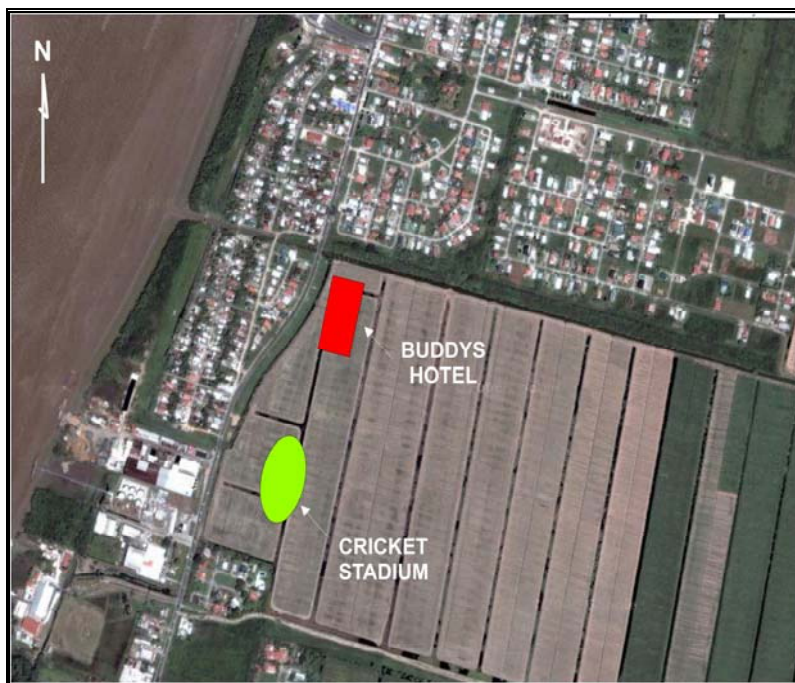
Plate 4.1: Showing footprint of Hotel

This is a reasonable approach since the area disturbed is relatively small and lies within a much larger area that is homogenous in its bio-physical characteristics. Plate 4.1 shows the footprint of the hotel within the larger context of expansive cane fields and surrounding communities as well as the proximity of the hotel site to the Demerara River. Physical, biological and socio-economic assessments were carried out and the results are presented below.

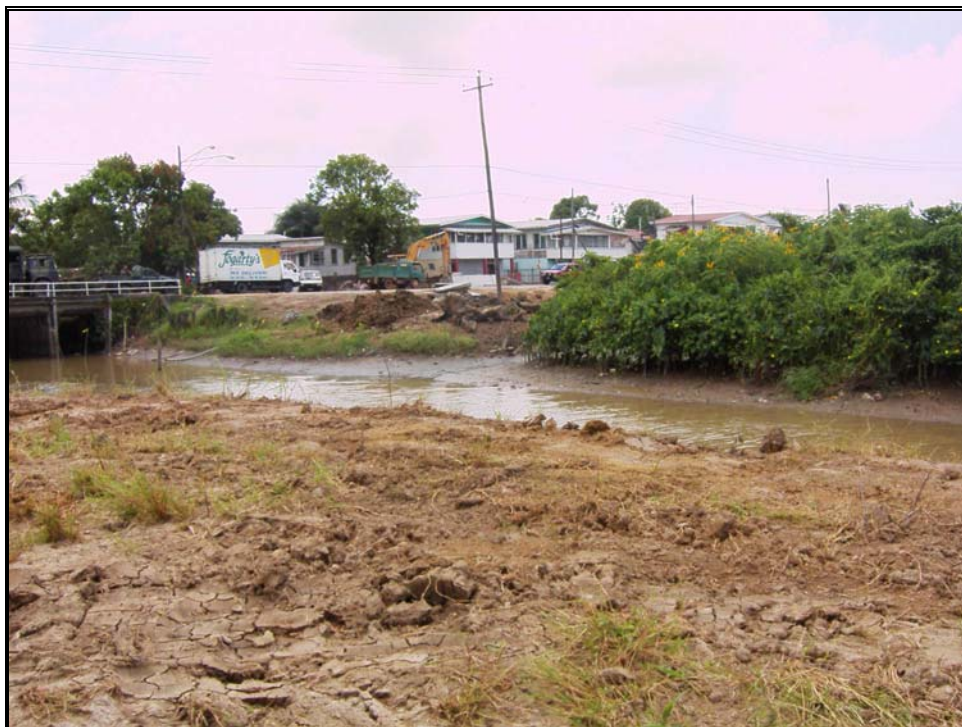
The hotel site is located about 1 km from the East bank of the Demerara River. It is flat with negligible grade and is bounded by an artificial drainage channel to the north and the west, Plate 4.3.1. There are no distinct geomorphological features and the land surface is about 1 meter below high water level.

Plate 4.2.3 Drainage channel to north and west of hotel.

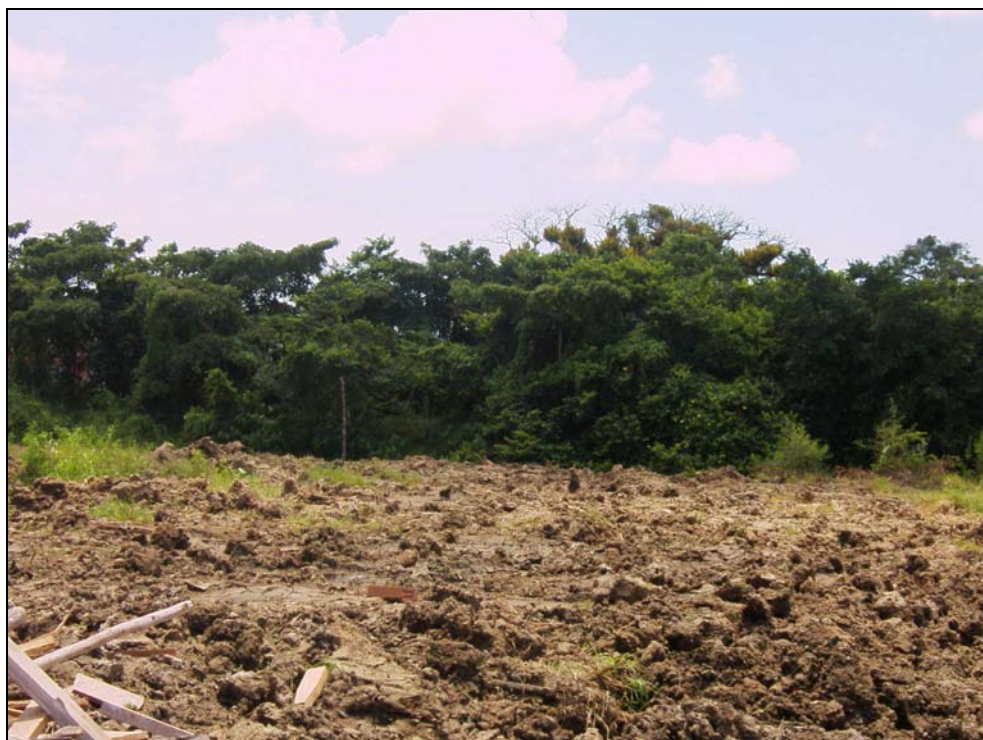
The project site is located on the Coastal Plain of Guyana where the soils are predominantly alluvial deposits over organic material and silts comprising the Demerara clay with localized pockets of peat (pegasse). Four different types of clays are associated with the Demerara Formation; the Mara Clay, Brickery Clay, Tuschen Clay and Lama Muck. At the project site the clay exposed at the surface consists of the Demerara Clay.

Plate 4.2.4: Project site is predominantly clay

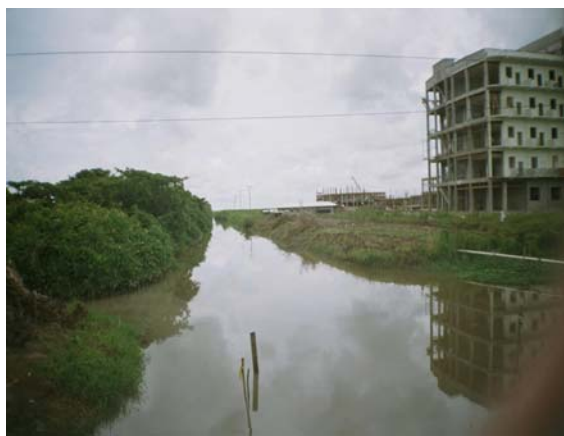
As part of the old sugar plantation the area of the hotel site was drained by a network of drainage channels that discharge via sluice gates into the Demerara River, Plate 4.2.6.2. The drainage channel that forms northern boundary of the hotel property Plate 4.2.6.1 is a major channel that discharges into the Demerara River via the Peters Hall sluice to the west of the hotel site. A smaller drainage channel is found on the western side of the property that connects to the larger channel. The entire network is connected Peters Hall sluice which also drains the residential areas in Republic Park, Nandy Park and Bagotstown. These areas are well drained and the hotel effluent will not impact significantly on the system.

Plate 4.2.6.1: Drainage Canal north of the Project Area

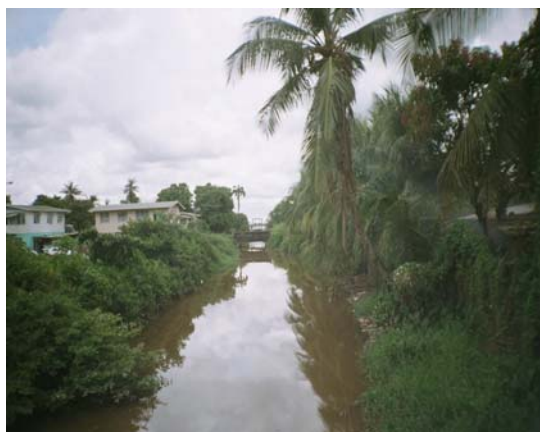
Plate 4.2.6.2: Drainage Outfall to the Demerara river West of Project Area

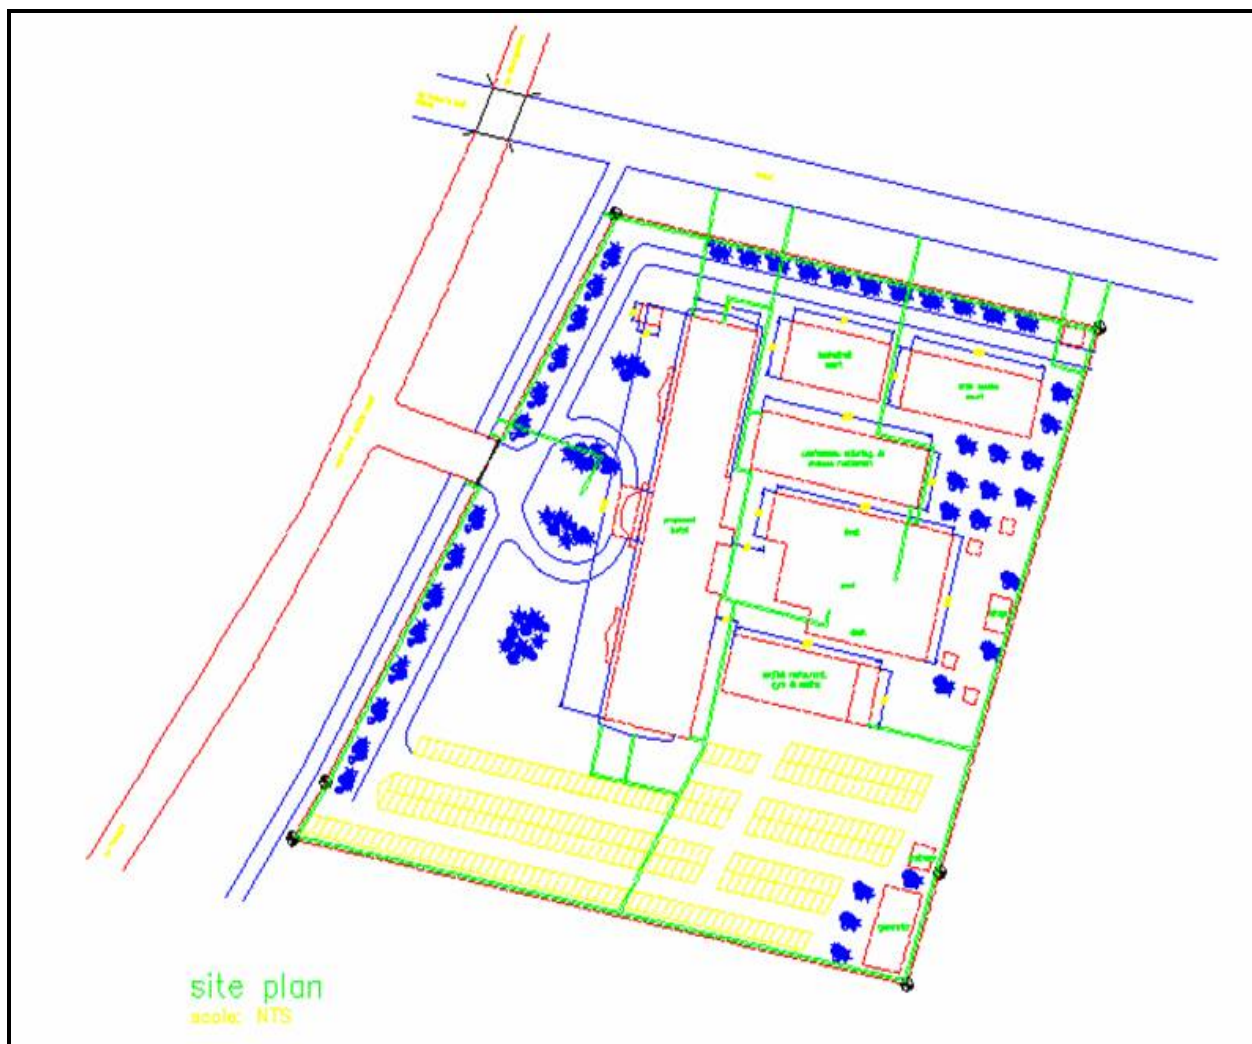
The flood event of 2005 is a reference point for community memory of flooding. Respondents questioned pointed to severe flooding during the period but of limited duration. In the industrial area, serious flooding was also reported in 2005, and is still seen as a potential threat to the area. The client has put in place a system of concrete drains around the periphery of the building, see drainage plan of site Fig 4.2.8 and as mentioned before the Peters Hall Sluice is capable of taking off the additional volume of stormwater.

Fig: 4.8.2 Showing Drainage Plan of hotel site (depicted by green lines)

The impervious surface created by the hotel building, adjoining restaurant, conference centre and other amenities will be about 75% of the hotel land area. Add to the surface areas of asphalted roads and it becomes apparent that the site will generate an additional amount equal to what would have previously infiltrated to the soil during the periods of prolonged rainfall. The client has put in place a system of concrete drains around the periphery of the building and as mentioned before the Peters Hall Sluice is capable of taking off the additional volume of storm water.

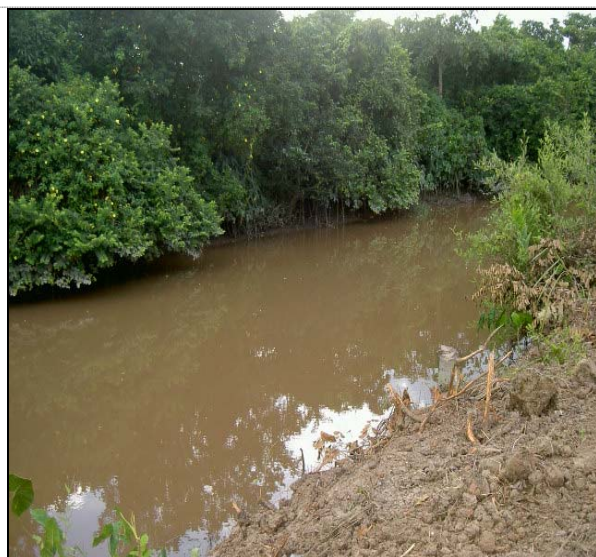
Plate 4.3.1.2: drainage channel at the hotel site.

Large drainage channels that drain the land around the site form an artificial aquatic habitat. The construction of the hotel is not expected to change the drainage channels. There are no endangered species or sensitive habitat on the hotel site.

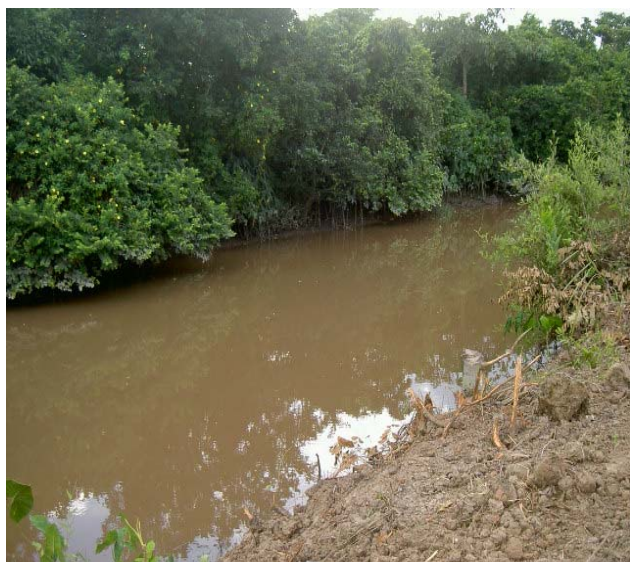
Plate 4.3.2.1: Aquatic Vegetation in Canal North of Hotel

Aquatic vegetation observed in the canals include alligator eye (*Salvinia auriculata*) and water lettuce (*Pistia stratiotes*). The species listed in Table 4.3.2 were either seen growing on the periphery or in the northern strip of land and other immediate surroundings, or in water bodies in these places.
